Engineering - Landscape Architecture - Surveying

Project Name	24015 Double Branch CDD		
Prepared By	Mike Silverstein		
Date Of Visit	12/02/2024 2:03 PM EST		
Date Prepared	12/02/2024 EST		
Weather	Clear	Temp	61
Site Conditions		Date of Last Report	N/A
Present at Site

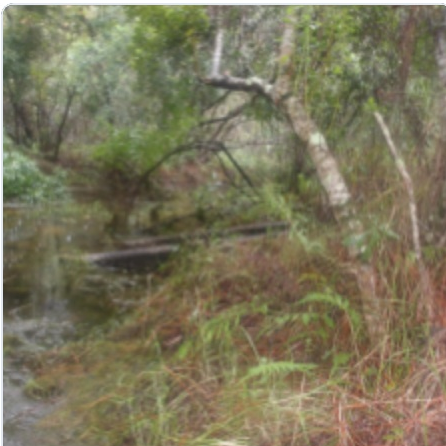
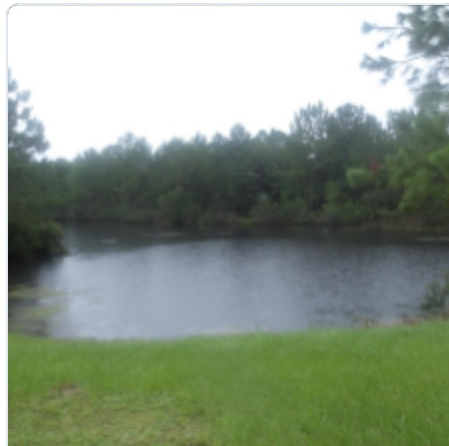
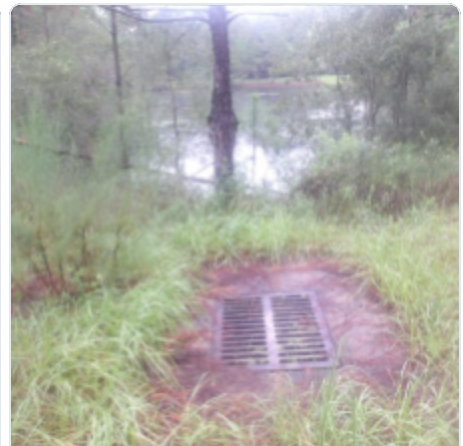
1

Structure functioning as designed.

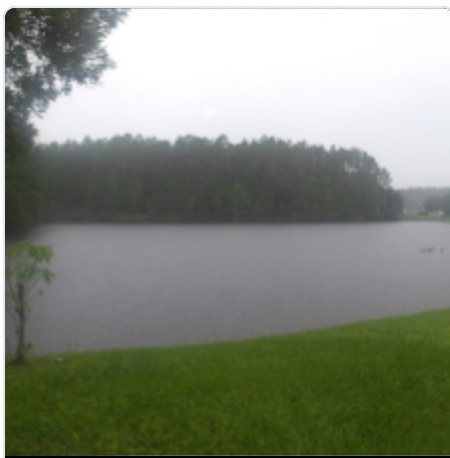
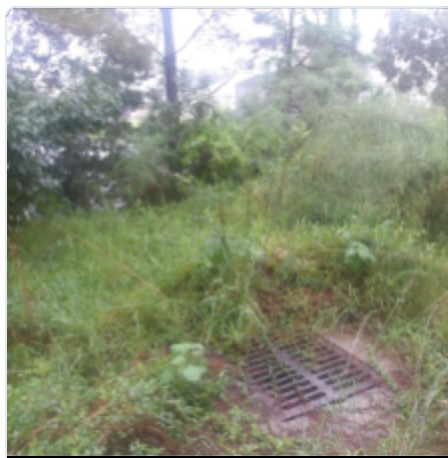
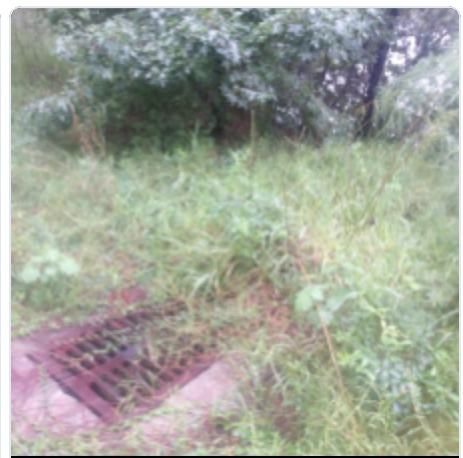
4

Structure operating as designed.

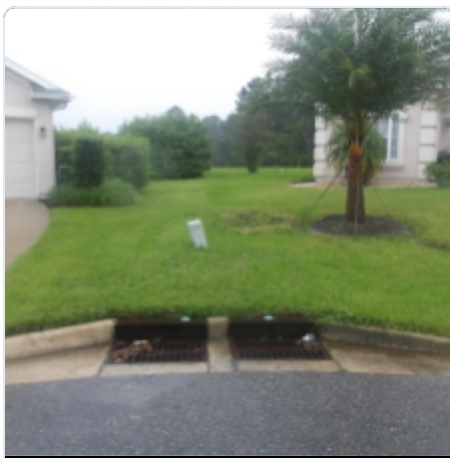
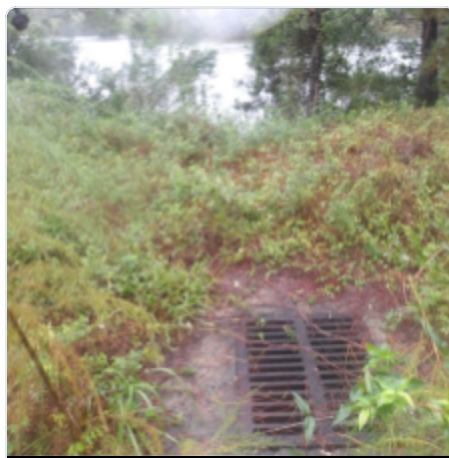
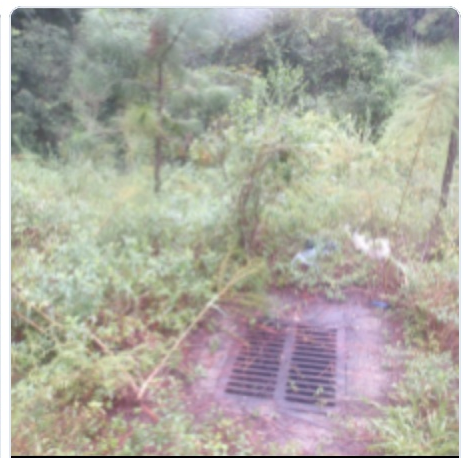
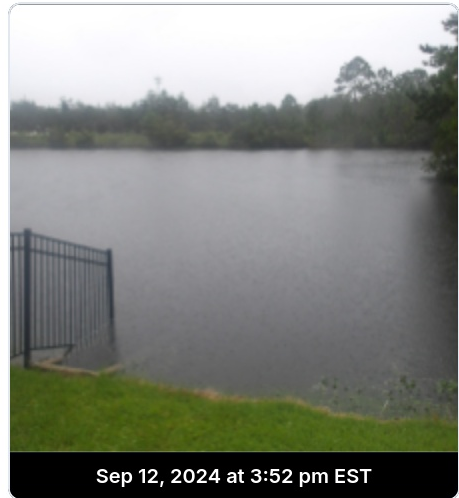
5

Structure operating as designed.

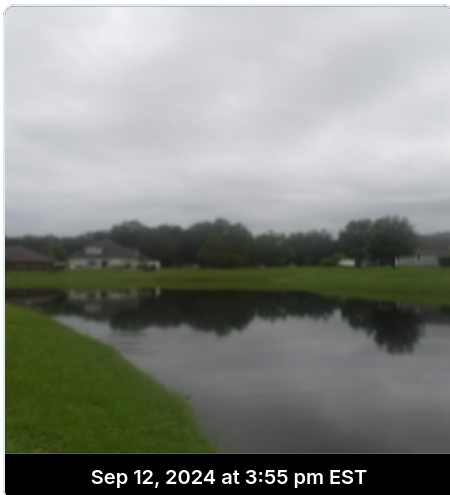
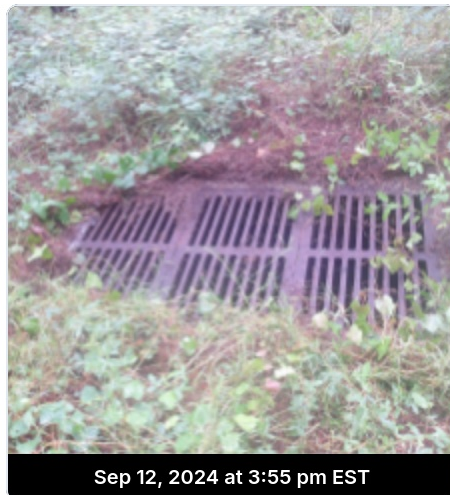
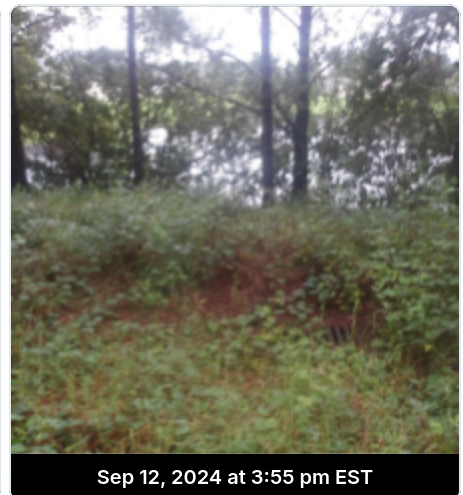
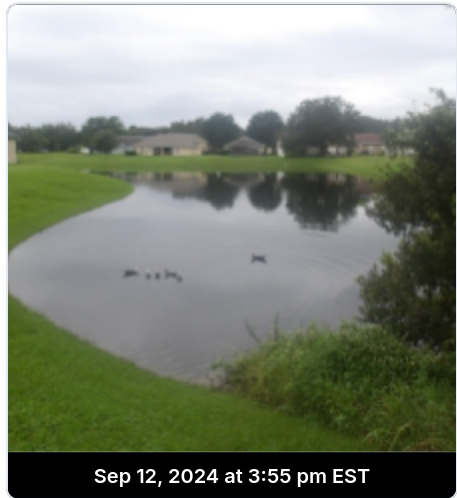
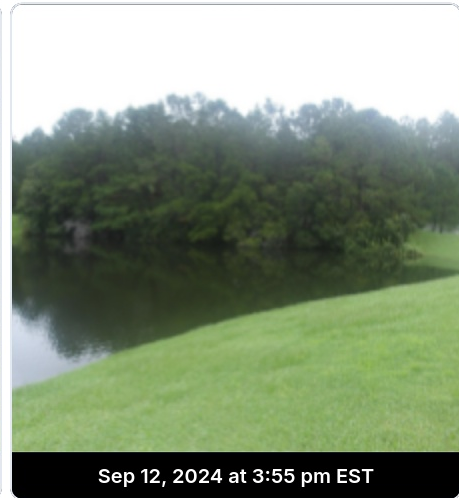
6

Structure operating as designed.

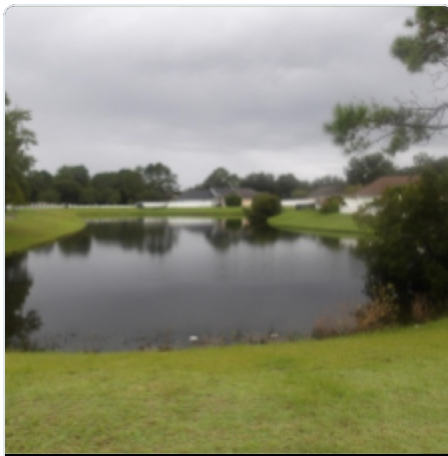
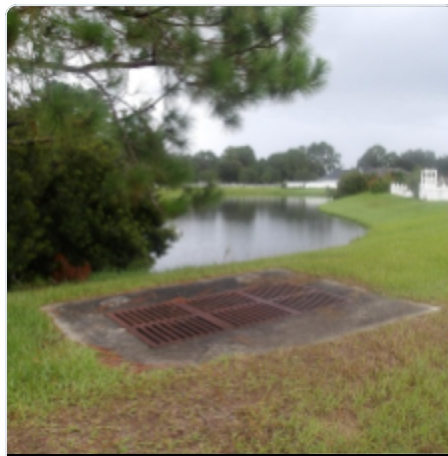
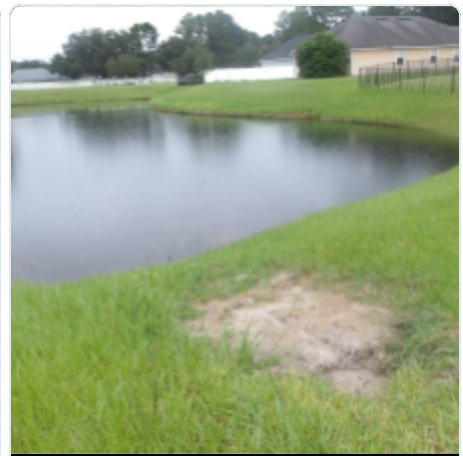
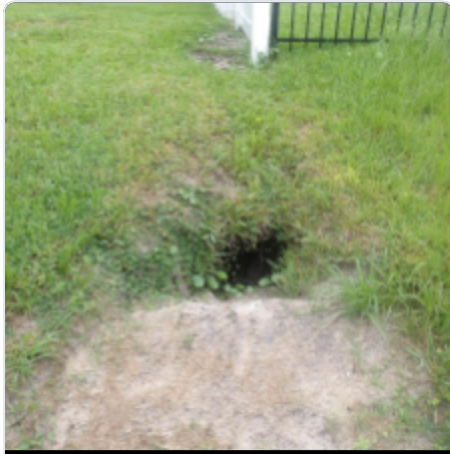
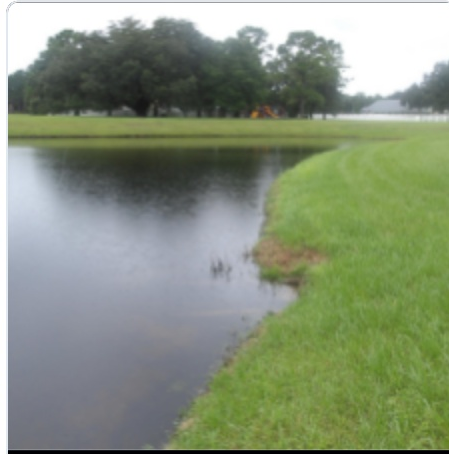
5 **7** Needs Action

Animal burrow found on pond bank - Consult with environmental on animal species (possible gopher tortoise) or if active.

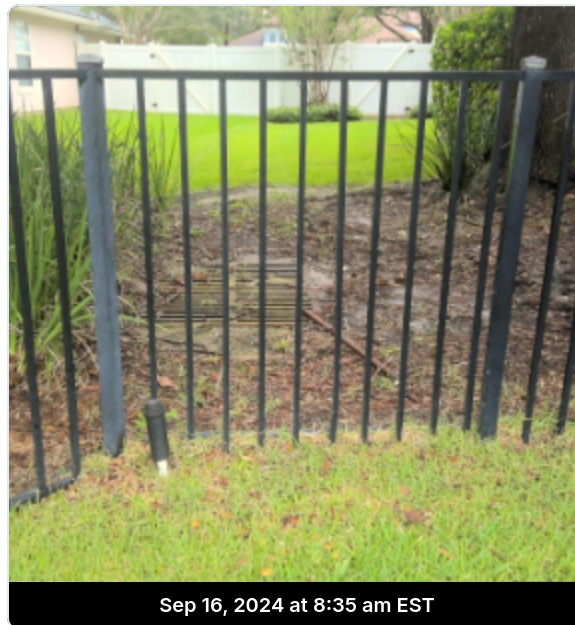
8

Structure operating as designed.

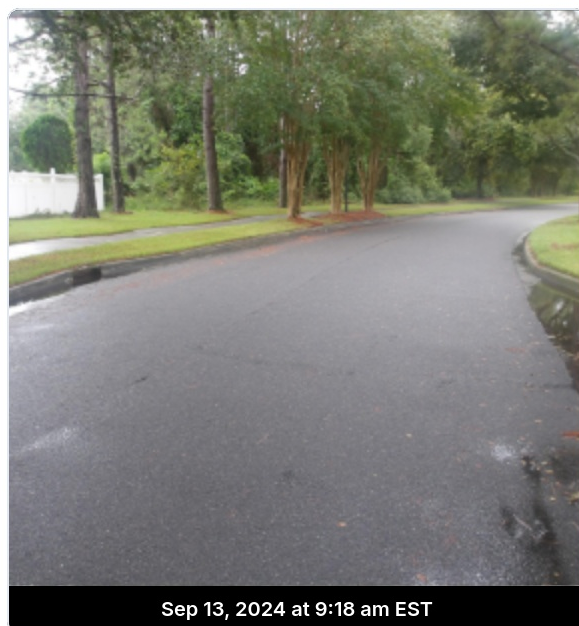
11

Ryan Morgan September 13, 2024 9:18 AM EST
Possible clog at both curb inlets, storm water staging up into gutter and roadway.

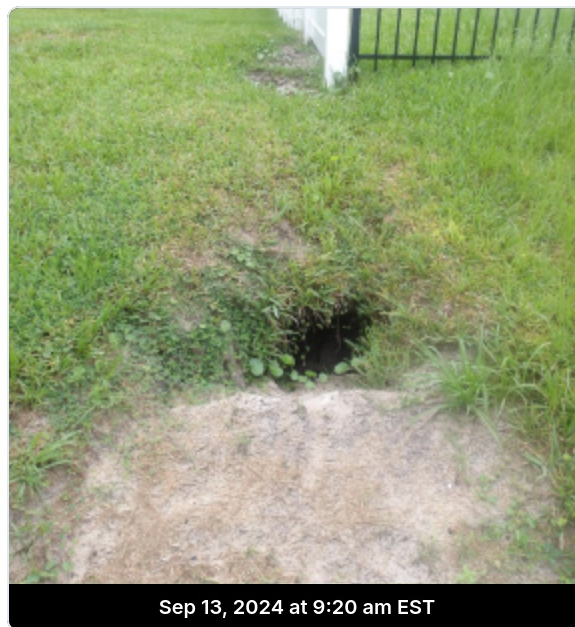
13

Animal burrow - Consult with environmental on animal species (possible gopher tortoise) - Mentioned in Item #7.

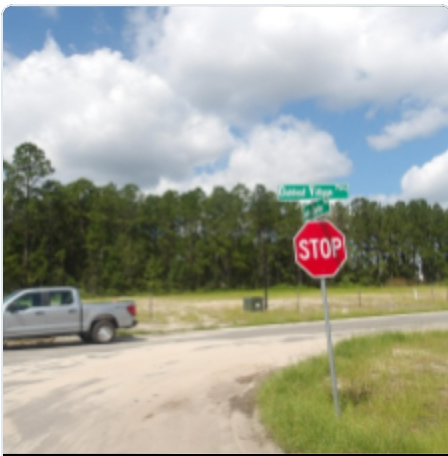
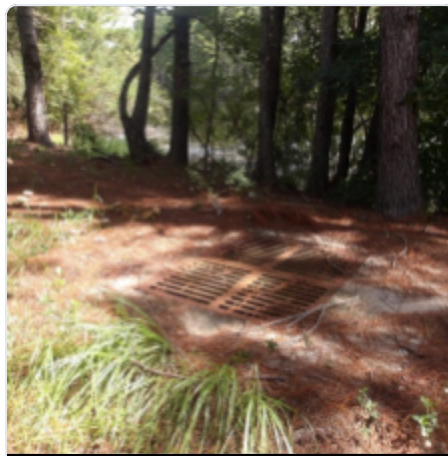
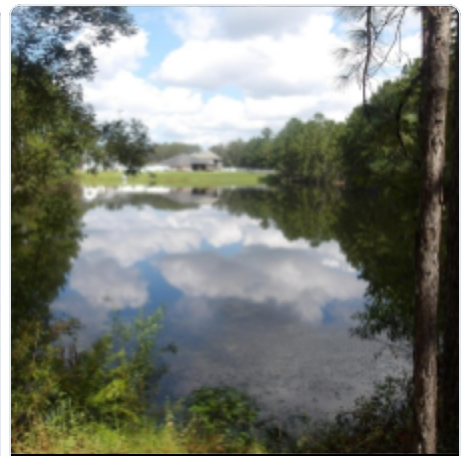
20

Structure is functioning as designed.
