General Information

Project Name	24015 Double Branch CDD		
Prepared By	Branden J Marcinell		
Date Of Visit	06/10/2025 11:57 AM EDT		
Date Prepared	06/23/2025 EDT		
Weather	Cloudy	Temp	93
Site Conditions		Date of Last Report	N/A
Present at Site

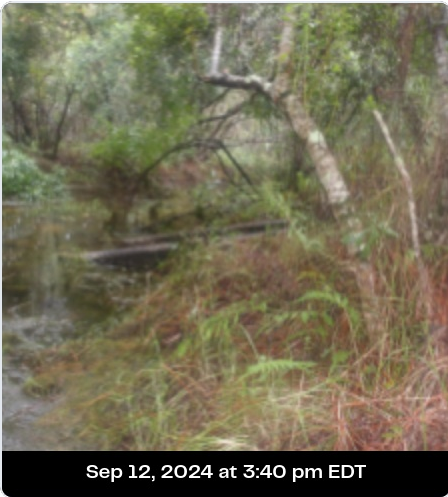
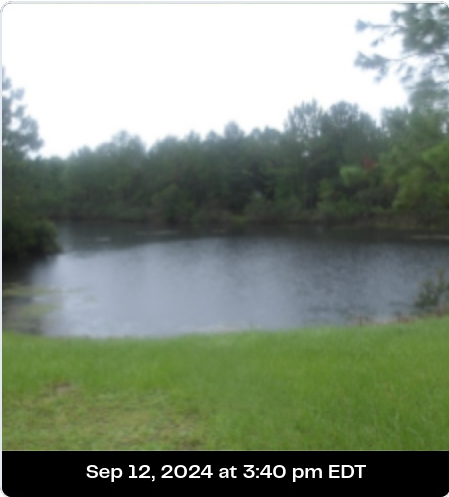
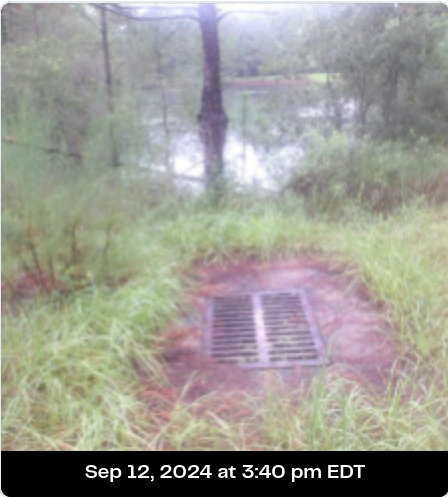
Mike Silverstein September 13, 2024 8:37 AM EDT
Structure functioning as designed.

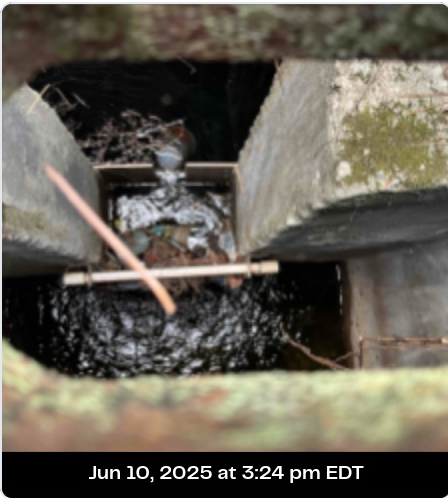
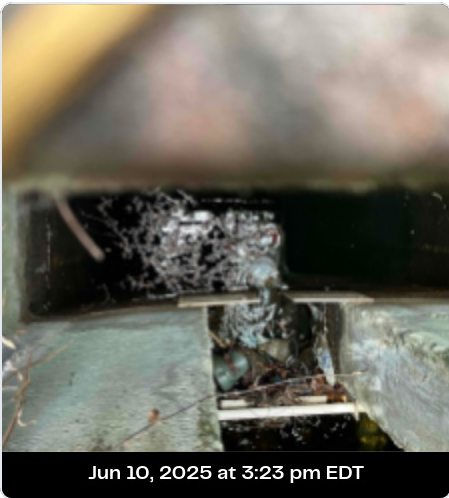
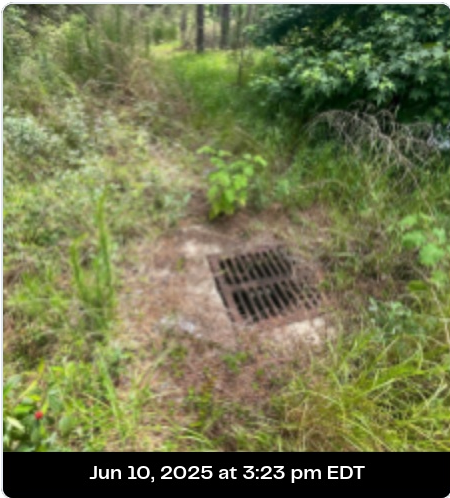
Branden J Marcinell June 10, 2025 3:29 PM EDT
Weir block by debris. Removed debris and vegetation to allow weir to operate as designed.

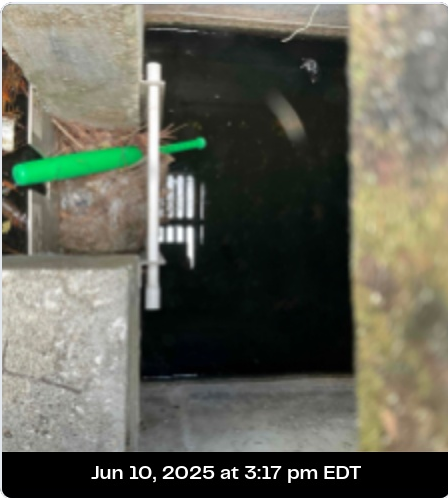
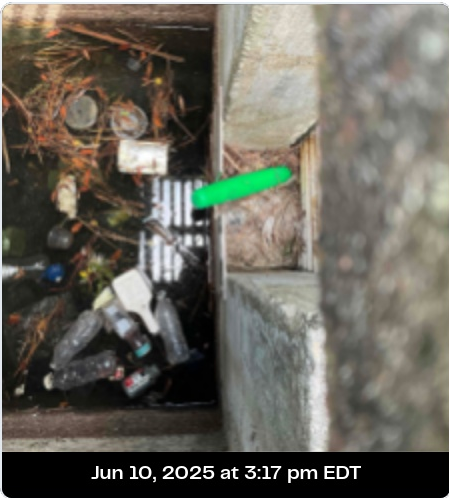
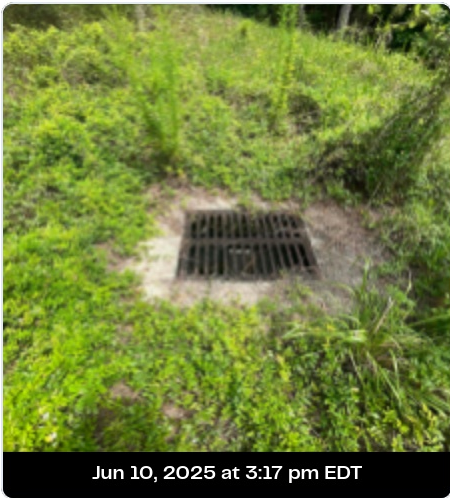
Branden J Marcinell June 10, 2025 3:22 PM EDT
Weir blocked by debris. Removed debris, clean out structure to allow weir to operate as designed.

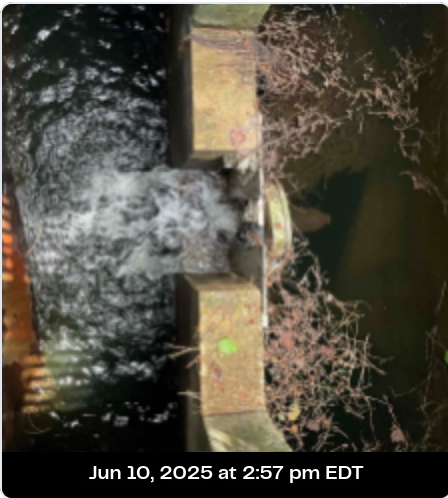
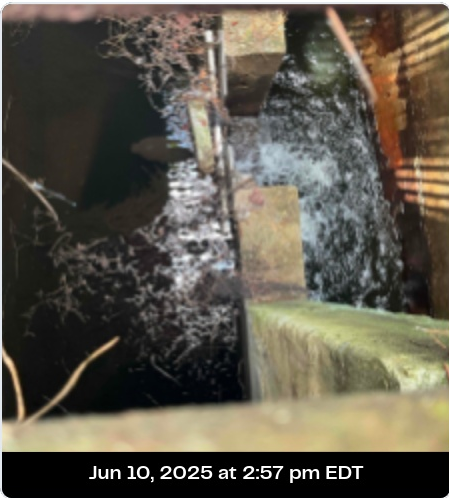
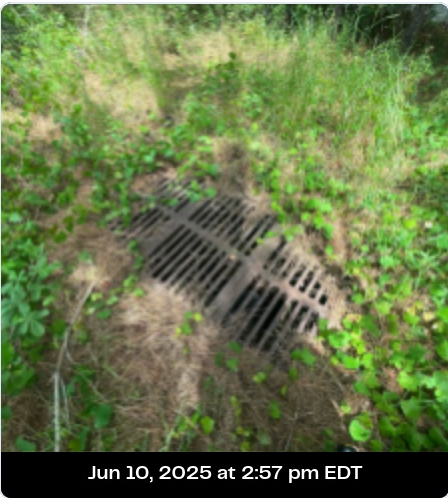
Branden J Marcinell June 10, 2025 3:06 PM EDT
Control structure weir is blocked by debris. Remove debris to allow weir to function as designed.

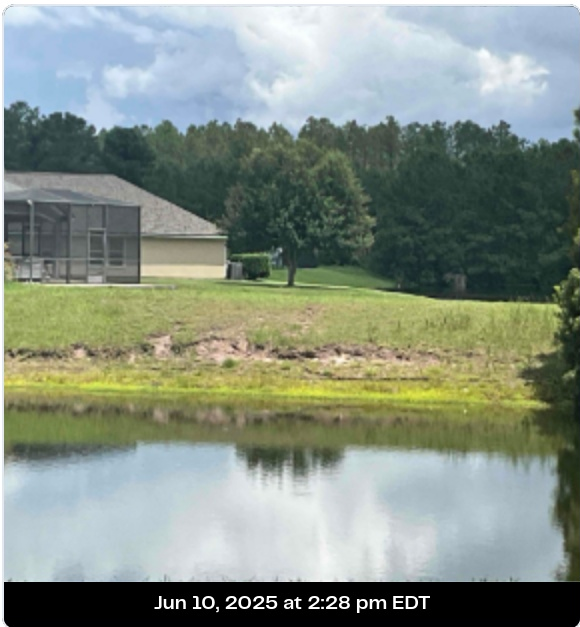
Erosion in pond bank. Re-stabilize to protect against erosion.

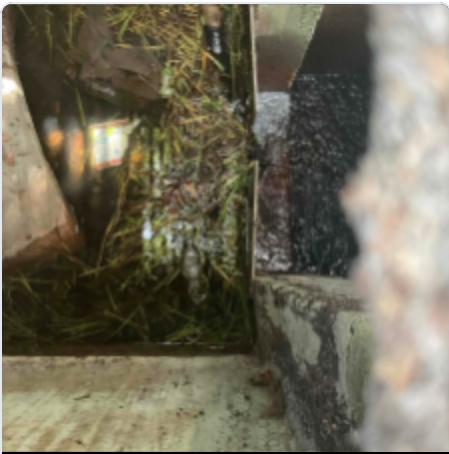
Branden J Marcinell June 10, 2025 2:22 PM EDT
Control structure weir blocked by vegetation. Remove vegetation to allow control structure to function as designed.

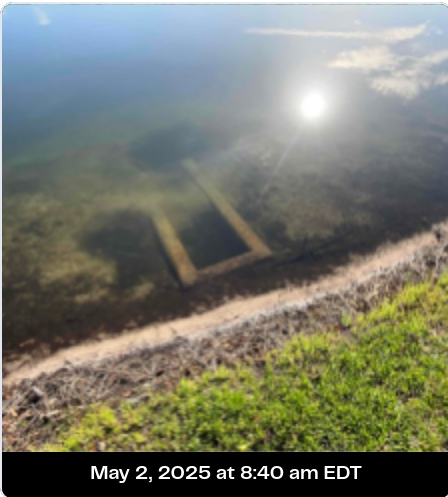
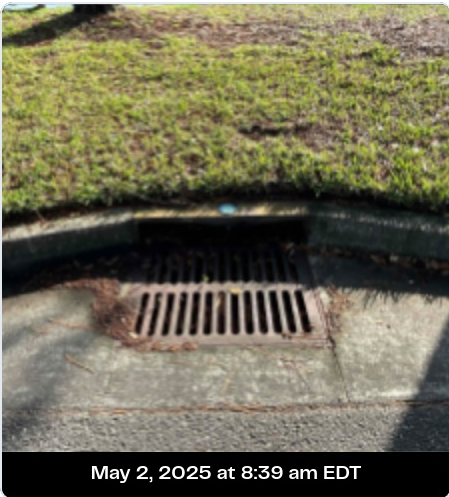
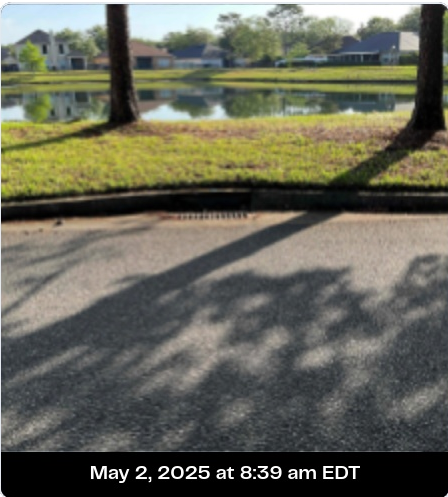
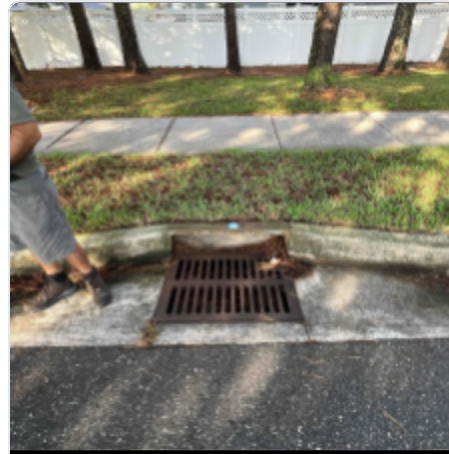
Confirmed clog at both inlets and discharging MES. CDD to facilitate vac truck to clear the pipe lines. This should be addressed immediately.

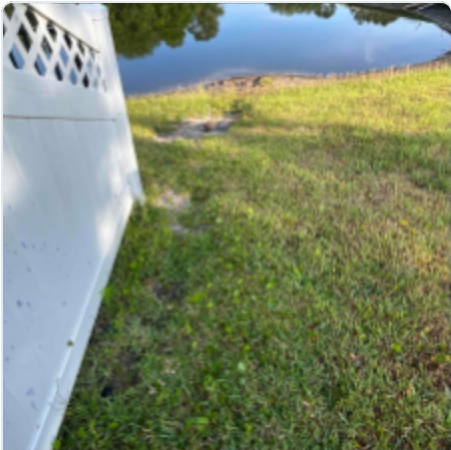
Pond bank washout possibly related to homeowner irrigation. CDD to reach out to homeowner and run corner sprinkler to see if that is causing the washout from overspray of the area or a leak in the irrigation system. This pin location was formerly classified as a possible animal burrow has been cleared now that the issue is confirmed to not be a burrow.

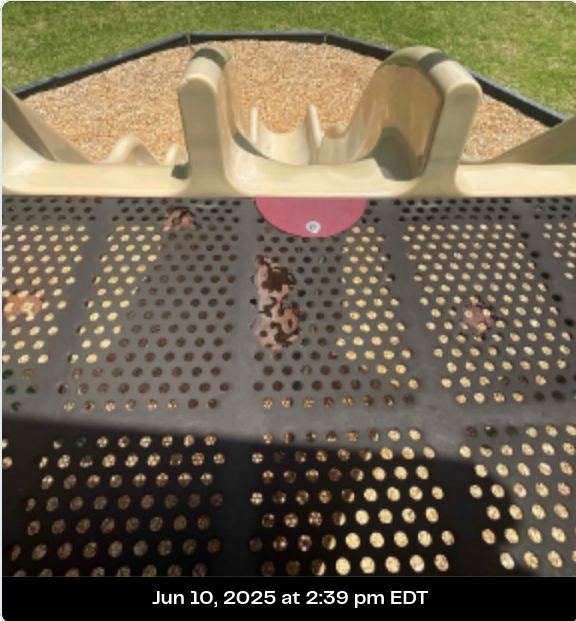
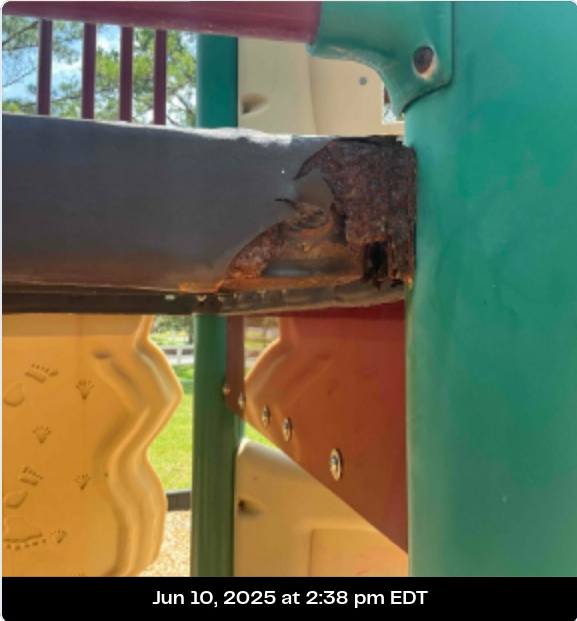
Exposed rust with sharp edges. Rusted support corner for walkway landing. Repair to protect from sharp edges and monitor for structural support in future inspections.

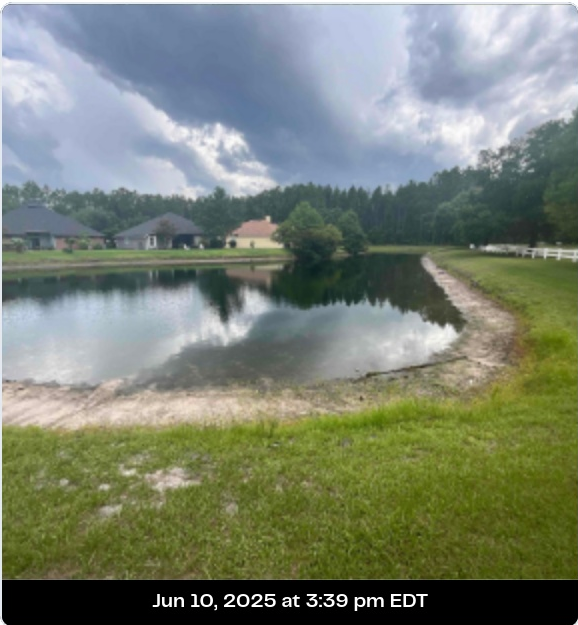
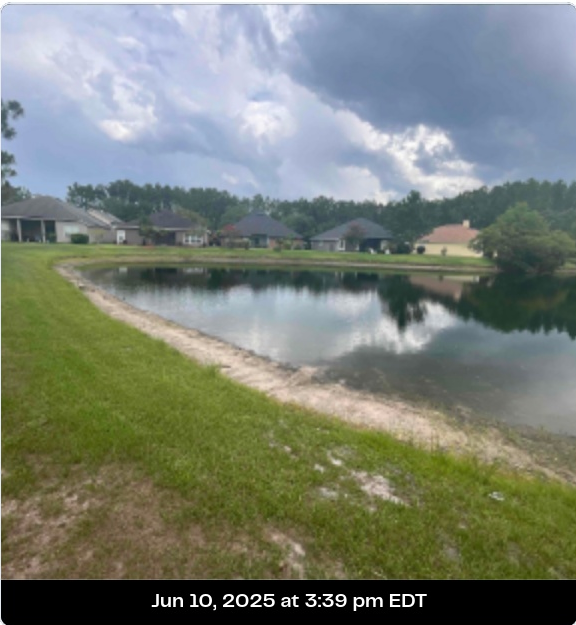
Branden J Marcinell June 10, 2025 3:41 PM EDT
Photo taken of pond for record purposes, only in comparison for future visits.

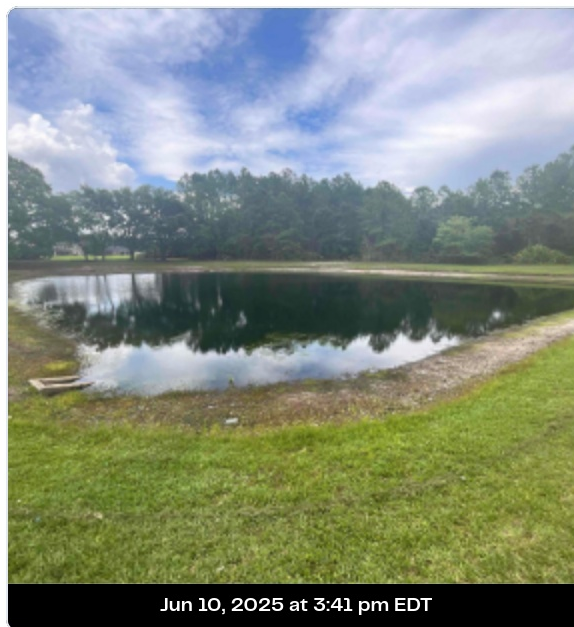
Photo taken of pond for record purposes, only in comparison for future visits.

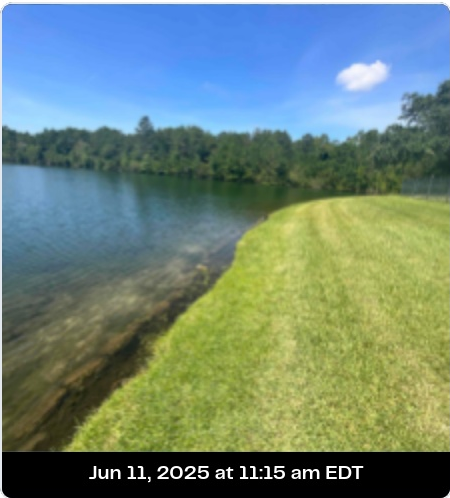
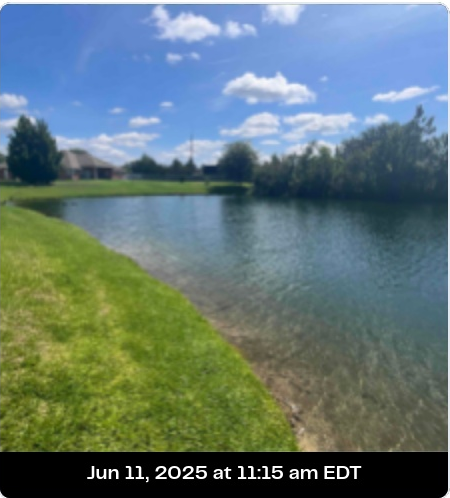
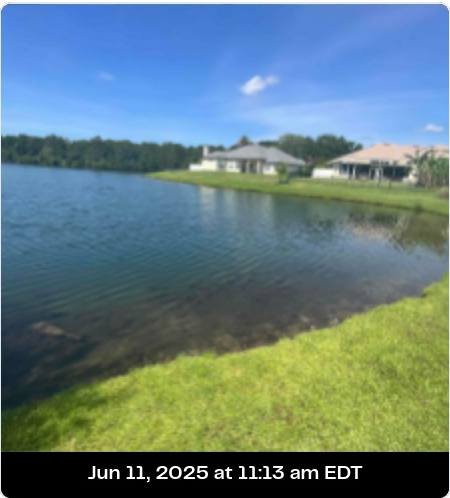
Branden J Marcinell June 11, 2025 11:18 AM EDT
Photo taken of pond for record purposes, only in comparison for future visits.

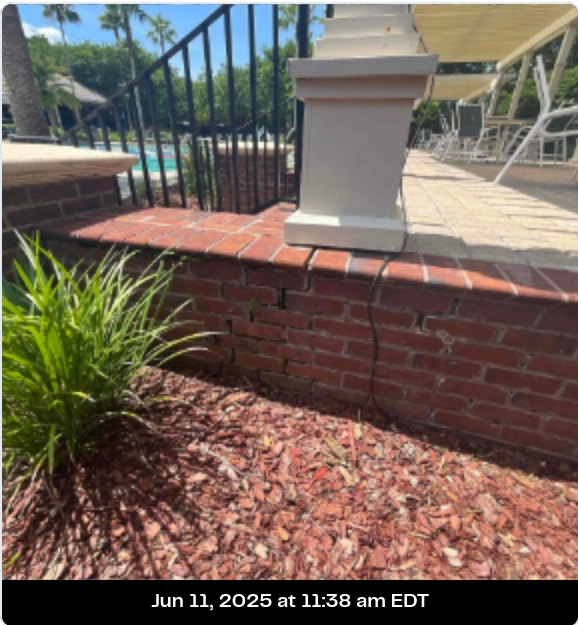
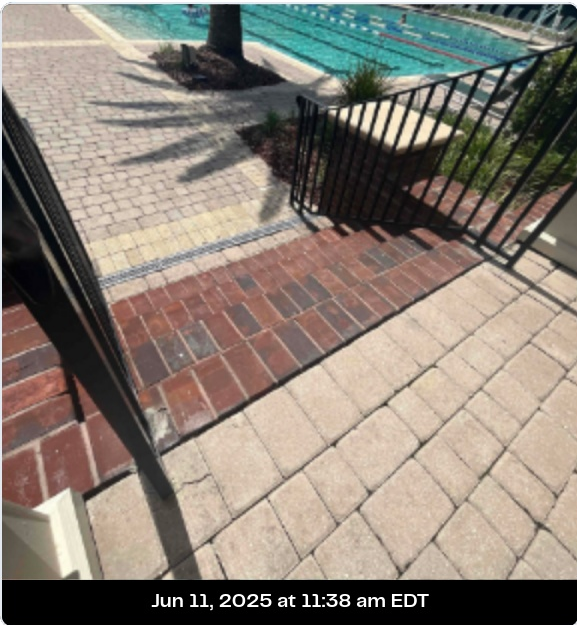
Branden J Marcinell June 11, 2025 11:39 AM EDT
Stairs appear to be settling and separating from pavers. Suggest inspection for stability.

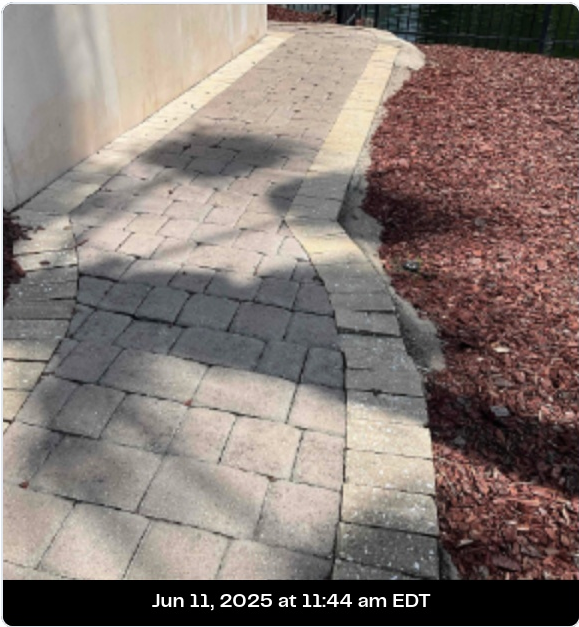
Branden J Marcinell June 11, 2025 11:45 AM EDT
Paver settling. Correct or monitor for worsening condition. Repair if progresses to trip hazard.

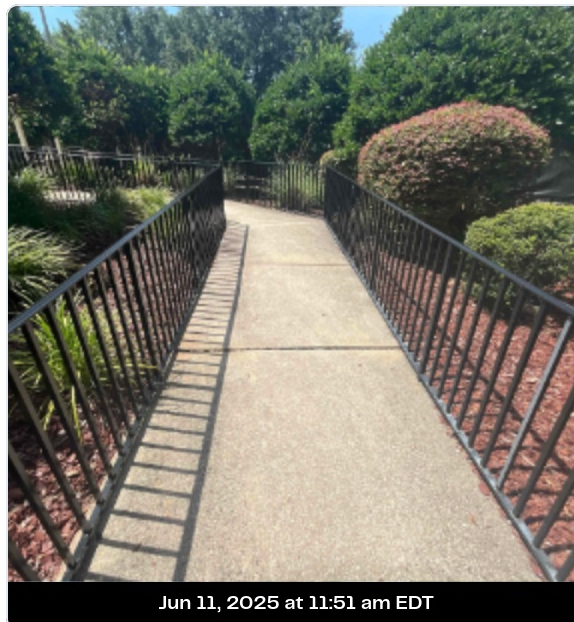
Minimal separation between concrete flags in sidewalk. Suggest shaving down to reduce change in elevations for trip hazard.
Monitor in future inspections.

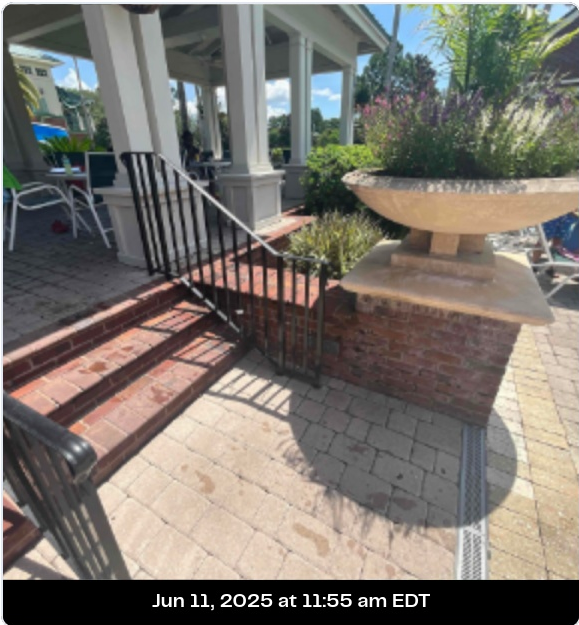
Branden J Marcinell June 11, 2025 11:58 AM EDT
Railing support is loose needs to be re-secured.

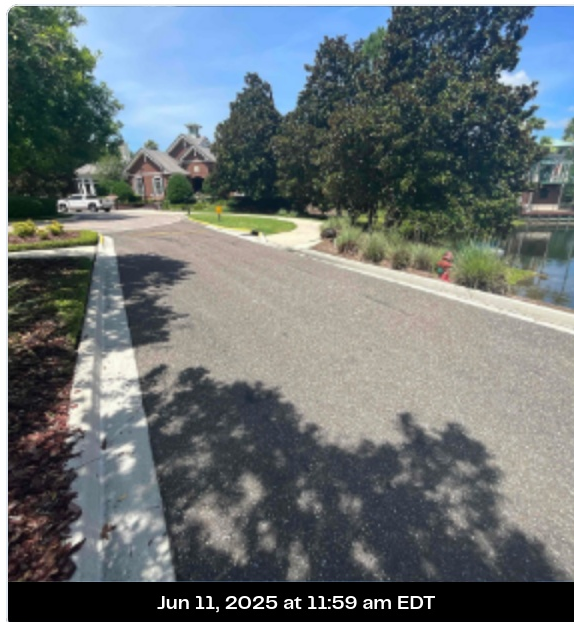
Missing blue reflector in roadway to identify hydrant location. Add blue reflector to roadway.

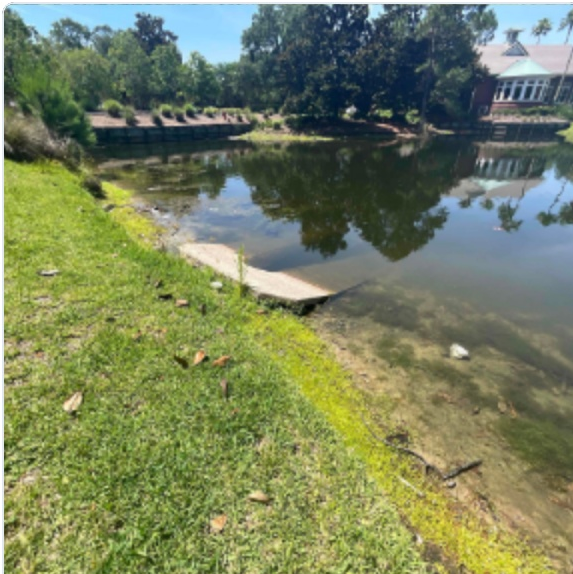
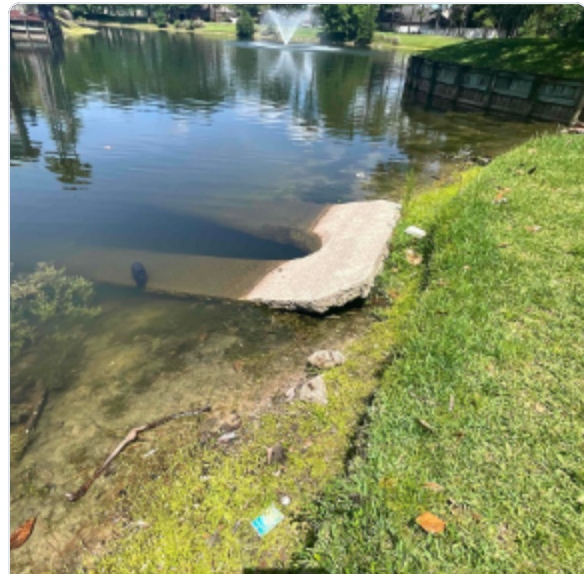
Erosion present around MES in the pond. Backfill and stabilize around edges of MES to protect against further erosion and possible concrete cracking.

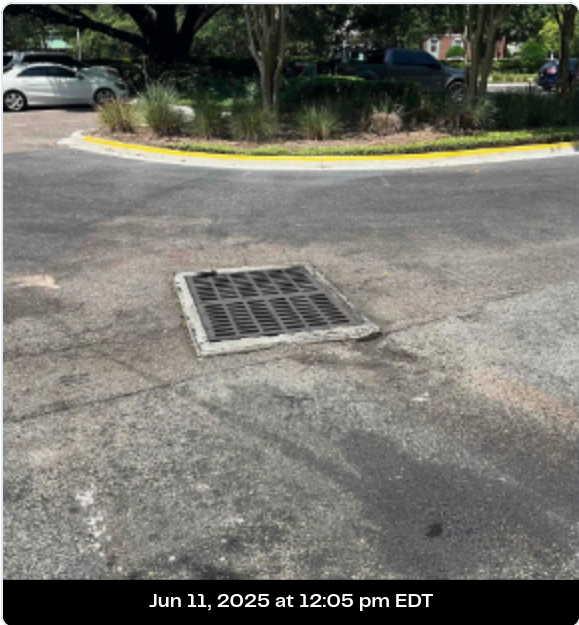
Branden J Marcinell June 11, 2025 12:11 PM EDT
Degraded pavement/depression near inlet in parking lot. Observe under future reviews.

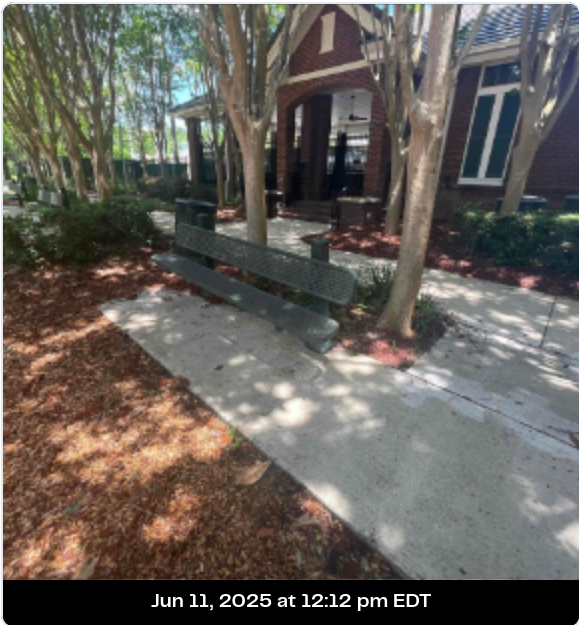
Branden J Marcinell June 11, 2025 12:12 PM EDT
Bench support is loose. Re-stabilize / secure for support.

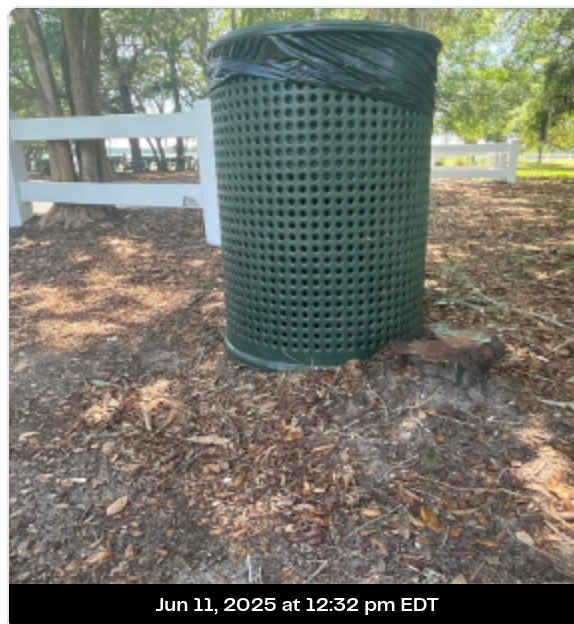
Exposed metal rust with sharp edges. Remove and re-secure trashcan.

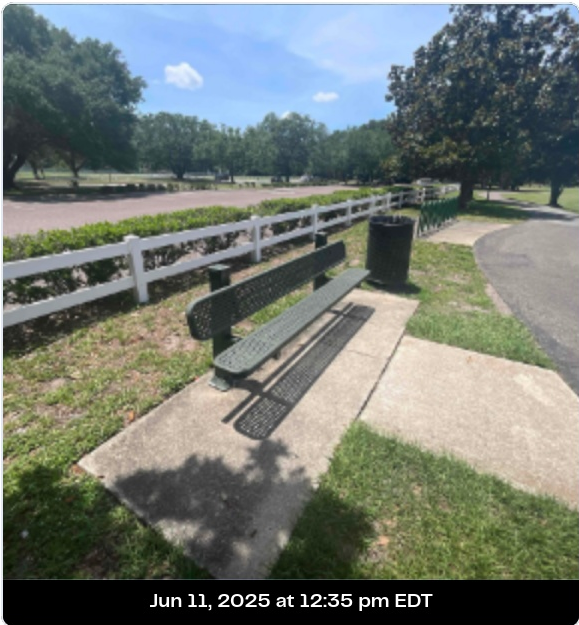
Bench support is loose. Monitor under future inspections.

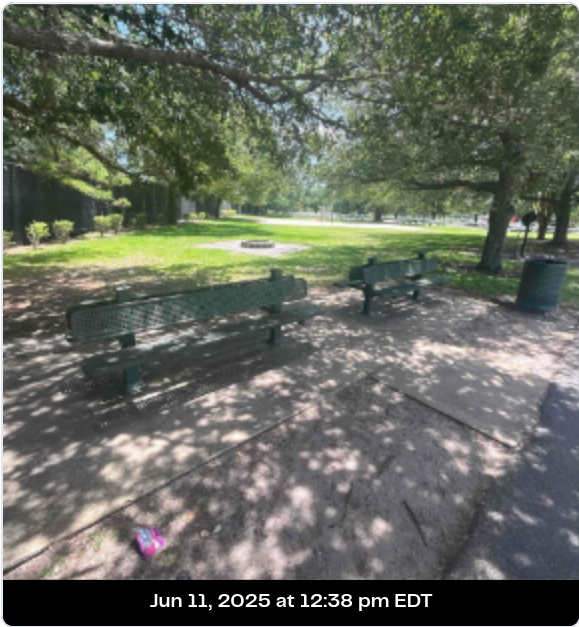
Bench support is loose. Monitor in future inspections.

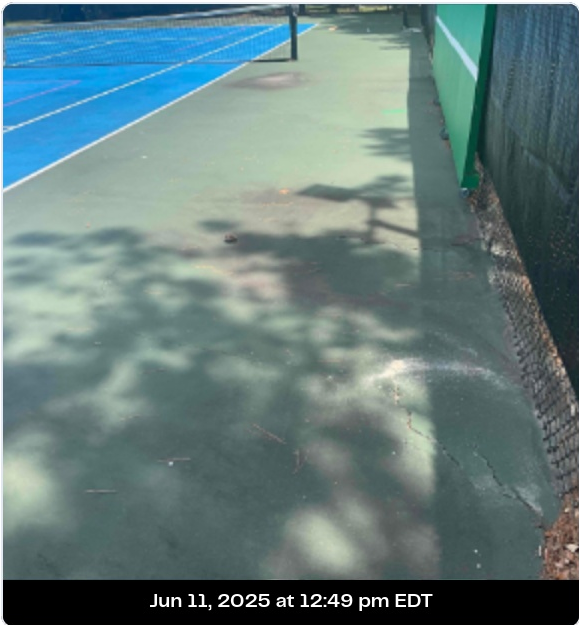
Branden J Marcinell June 11, 2025 12:50 PM EDT
Depression and cracking in tennis court surface. Monitor in future inspections.

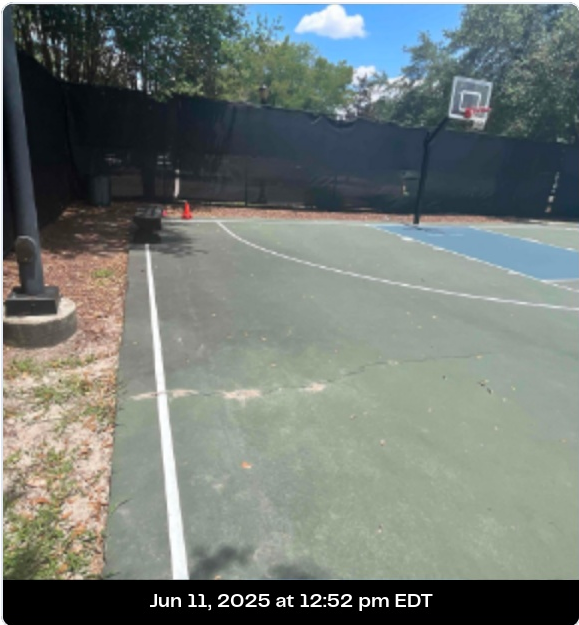
Branden J Marcinell June 11, 2025 12:53 PM EDT
Cracking in basketball court surface. Observe in future inspections.
