General Information

Project Name	24015 Double Branch CDD		
Prepared By	Branden J Marcinell		
Date Of Visit	06/10/2025 11:57 AM EDT		
Date Prepared	06/23/2025 EDT		
Weather	Cloudy	Temp	93
Site Conditions		Date of Last Report	N/A
Present at Site

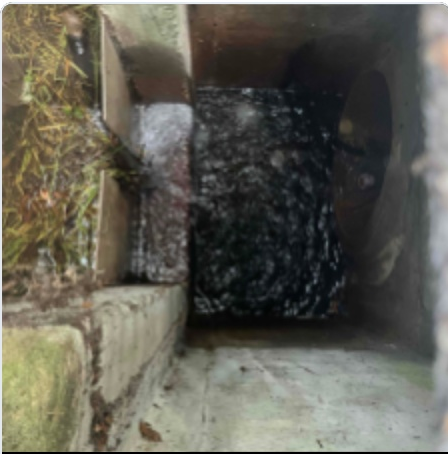
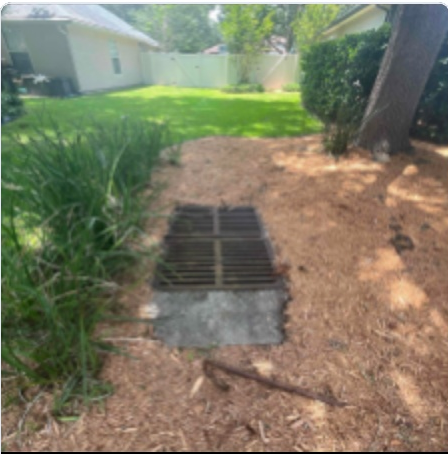
Branden J Marcinell June 10, 2025 2:22 PM EDT
Control structure weir blocked by vegetation. Remove vegetation to allow control structure to function as designed.

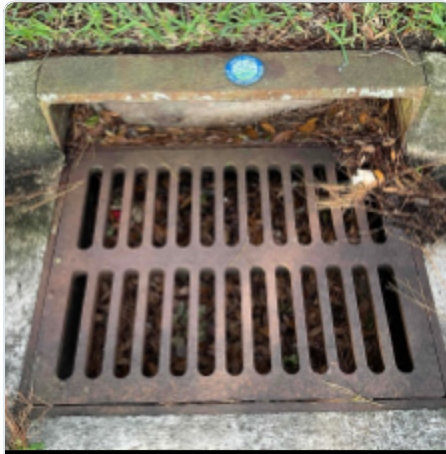
Confirmed clog at both inlets and discharging MES. CDD to facilitate vac truck to clear the pipe lines. This should be addressed immediately.

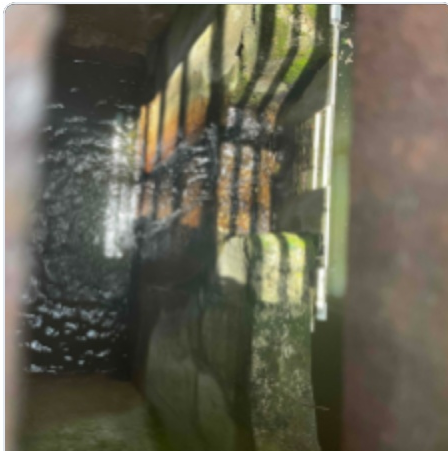
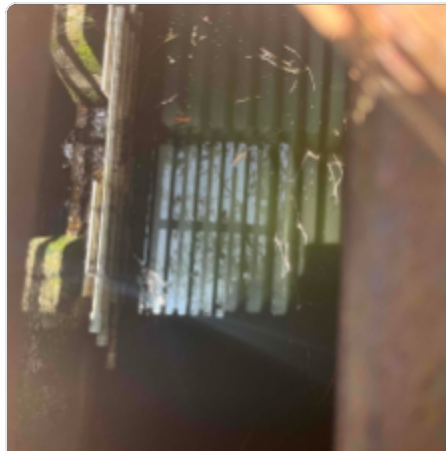
Outflow appears to be bypassing aluminum weir plate underneath through original concrete weir. Tightening the aluminum plate against the concrete weir for a watertight seal will be required for proper control structure, design function.

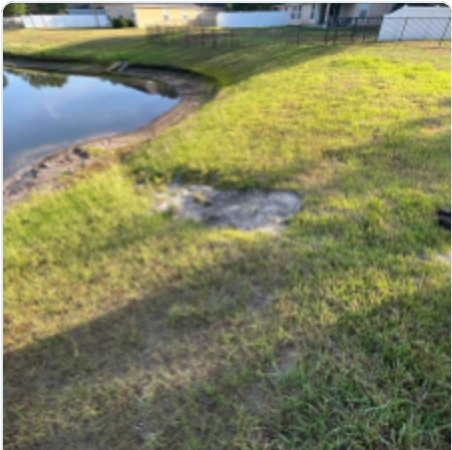
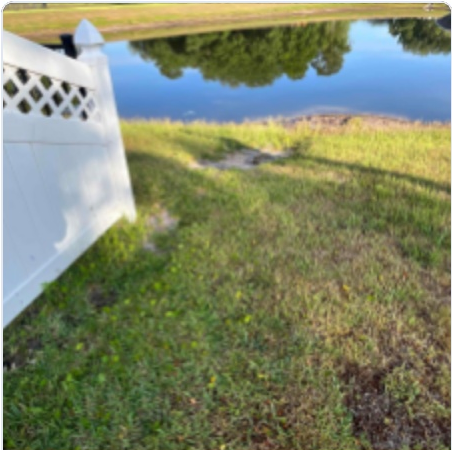
Pond bank washout possibly related to homeowner irrigation. CDD to reach out to homeowner and run corner sprinkler to see if that is causing the washout from overspray of the area or a leak in the irrigation system. This pin location was formerly classified as a possible animal burrow has been cleared now that the issue is confirmed to not be a burrow.
